EFFECT OF TWO BRAZE COATINGS,
PROCESSING VARIABLES, AND HEAT
TREATMENTS ON 1200° F STRESS-
RUPTURE STRENGTH OF L-605,
A-286, AND INCONEL 700 SHEET

by John H. Sinclair and Charles A. Gyorgak

*Lewis Research Center
Cleveland, Ohio*

TECHNICAL NOTE D-1880

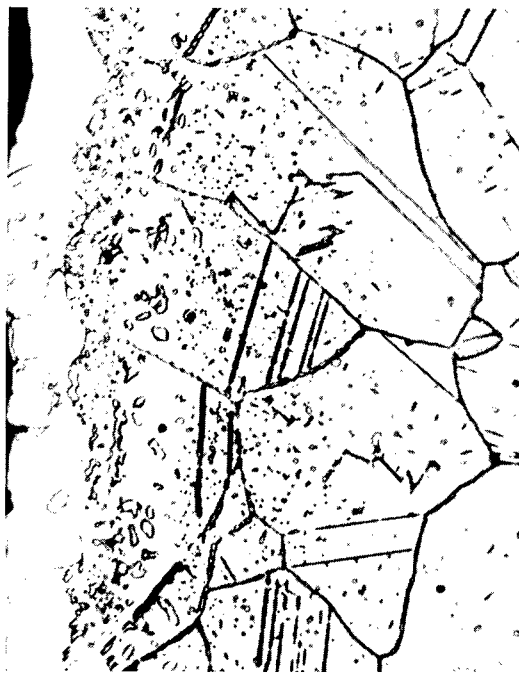
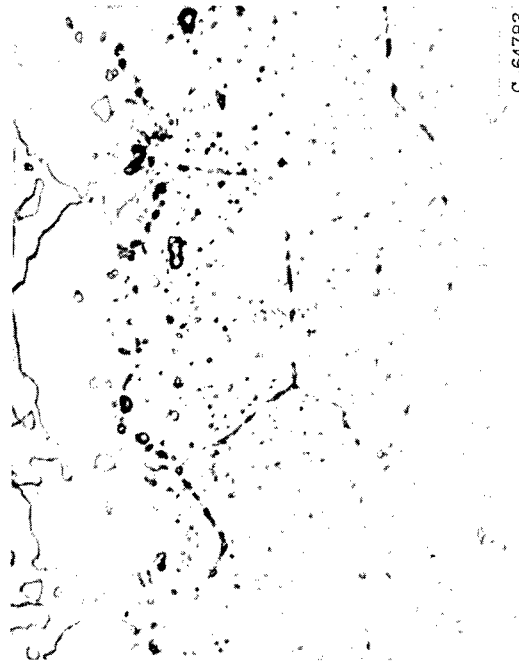
(a) As-received.

(c) NiCrSiB coated at 2075° F for 15 minutes.

(b) Braze-temperature-cycled at 2075° F for 15 minutes.

(d) NiCrSi coated at 2075° F for 15 minutes.

Figure 10. - Microstructures of L-605 stress-rupture specimens prior to testing. Electrolytically etched in a solution of 70 parts saturated boric acid solution, 30 parts 5 percent sulfuric acid solution. X900.

Comparative photomicrographs of specimens braze-temperature-cycled at these two temperatures are given in figures 10(b) and 13. Even though the specimen in figure 13 had been stress-rupture tested 3.8 hours, no significant metallographic differences were noted.

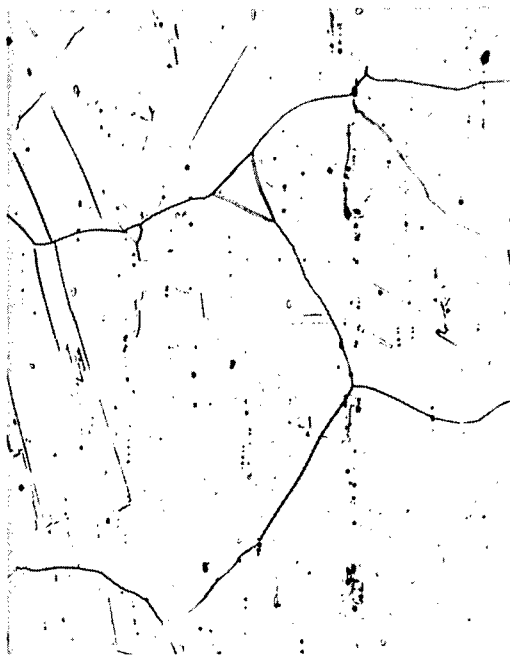
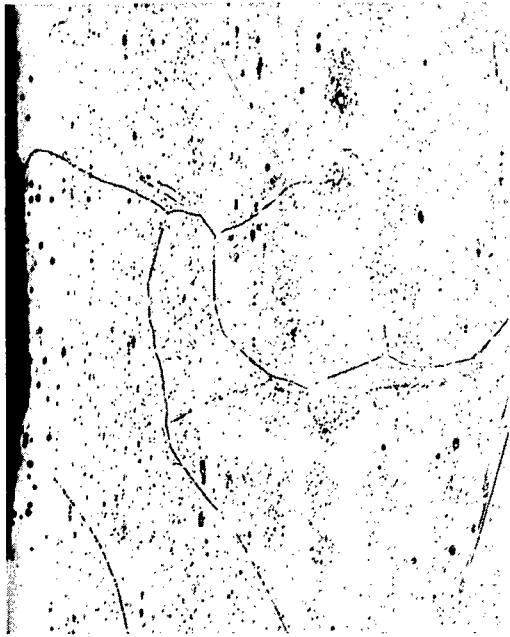
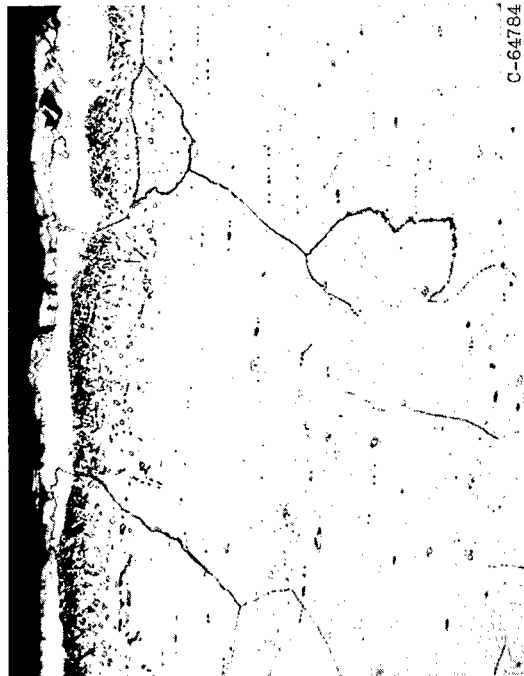
(a) Solution treated; operated 32.8 hours. Etched in glycerine - aqua regia.

(b) Solution treated and braze-temperature-cycled (2075° F) for 15 minutes; operated 3.5 hours. Etched in glycerine - aqua regia.

(c) Solution treated and NiCrSiB coated at 2075° F for 15 minutes. C-64784

Figure 12. - Microstructures of L-605 stress-rupture specimens. Solution treated at 2250° F for 30 minutes. Electrolytically etched in aqua regia in glycerine or solution of 70 parts saturated boric acid solution, 30 parts 5 percent sulfuric acid solution. X250.

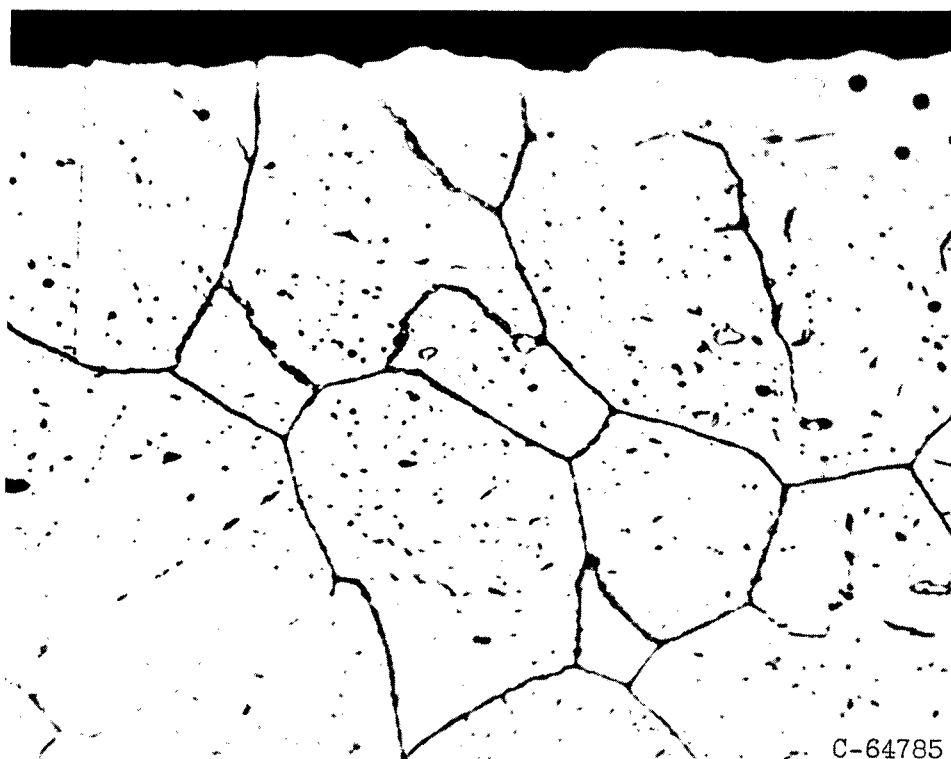
Figure 13. - Microstructure of L-605 stress-rupture specimen braze-temperature-cycled at 2150° F for 15 minutes; operated 3.8 hours. Electrolytically etched in solution of 70 parts saturated boric acid solution and 30 parts 5 percent sulfuric acid solution. X900.

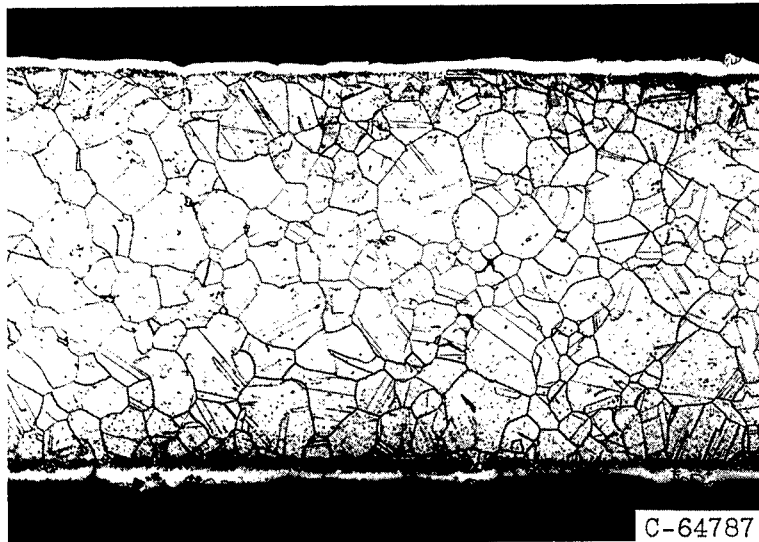
Figure 15. - Microstructure of L-605
NiCrSiB coated with 0.001-inch layer of
braze alloy. Brazing conditions: 2075° F,
15 minutes, vacuum. Electrolytically
etched in a solution of 50 percent dis-
tilled water, 40 percent hydrochloric
acid, and 10 percent nitric acid. X100.

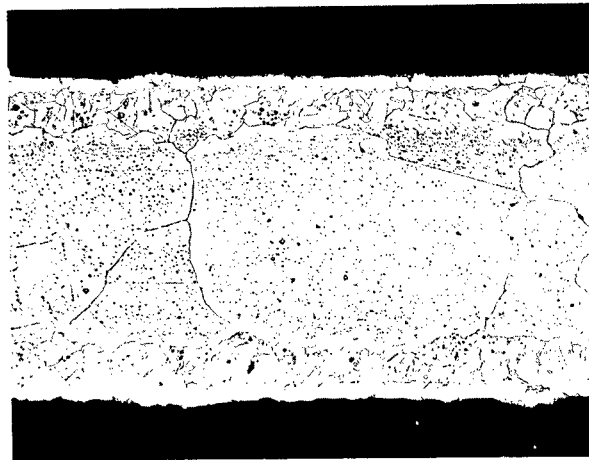
(a) As-received.

(b) Nickel plated.

(c) Nickel plated and braze-temperature-cycled at 2075° F for 15 minutes.

(d) Nickel plated and NiCrSiB coated at 2075° F for 15 minutes.

(e) Nickel plated and NiCrSi coated at 2075° F for 15 minutes.

Figure 16. - Microstructures of A-286 stress-rupture specimens prior to testing. Electrolytically etched in a solution of 50 percent distilled water, 40 percent hydrochloric acid, and 10 percent nitric acid. X100.

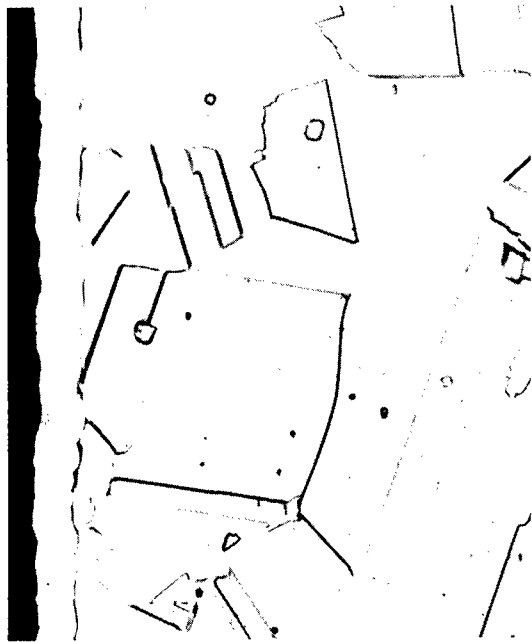
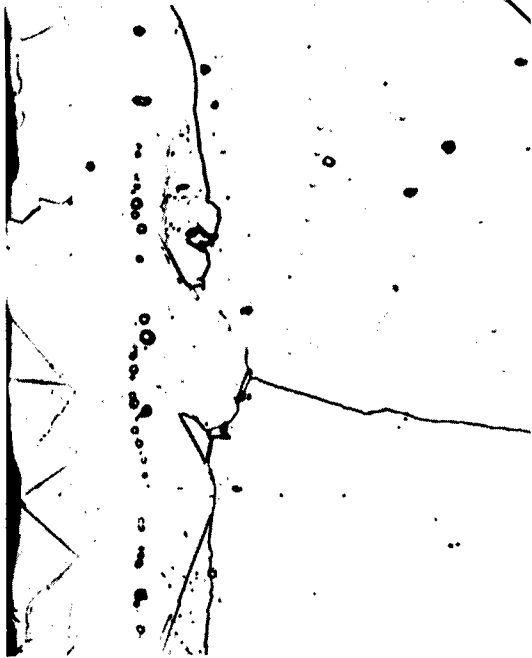
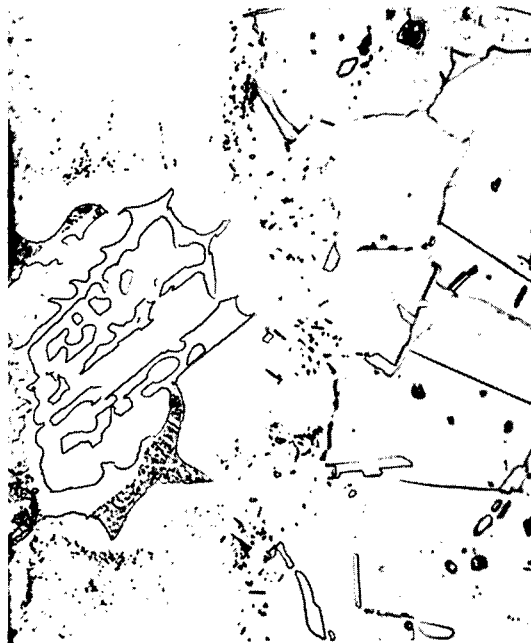
(a) Nickel plated.

(b) Nickel plated and braze-temperature-cycled at 2075° F for 15 minutes.

(c) Nickel plated and NiCrSiB coated at 2075° F for 15 minutes.

(d) Nickel plated and NiCrSi coated at 2075° F for 15 minutes.

Figure 17. - Microstructures of A-286 stress-rupture specimens prior to testing. Electrolytically etched in a solution of 50 percent distilled water, 40 percent hydrochloric acid, and 10 percent nitric acid. X900.

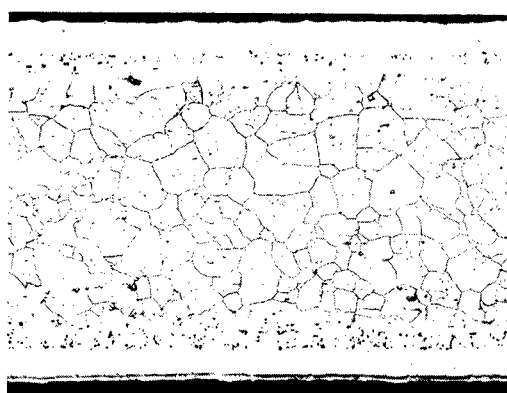
(a) As-received.

(b) Braze-temperature-cycled at 2075° F for 15 minutes.

(c) Nickel plated.

(d) Nickel plated and braze-temperature-cycled at 2075° F for 15 minutes.

(e) Nickel plated NiCrSiB coated at 2075° F for 15 minutes.

(f) Nickel plated and NiCrSi coated at 2075° F for 15 minutes. Etched in 92 parts hydrochloric acid, 5 parts sulfuric acid, 3 parts nitric acid.

Figure 18. - Microstructures of Inconel 700 stress-rupture specimens prior to testing. Electrolytically etched in a solution of 50 percent distilled water, 40 percent hydrochloric acid, and 10 percent nitric acid unless otherwise noted. $\times 100$. Photographs reduced 39 percent.

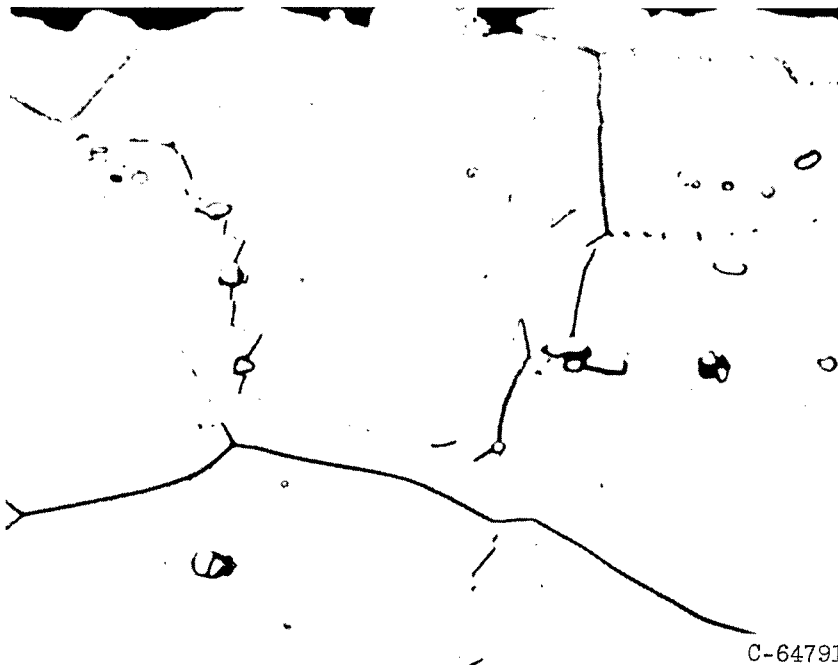
(a) As-received.

(b) Braze-temperature-cycled at 2075° F for 15 minutes.

Figure 19. - Microstructures of Inconel 700 stress-rupture specimens prior to testing. Electrolytically etched in a solution of 20 parts glycerine, 20 parts water, 10 parts nitric acid, 5 parts hydrofluoric acid. $\times 900$. Photographs reduced 23 percent.
